**FINAL GENERIC
ENVIRONMENTAL IMPACT STATEMENT**

White Pine Commerce Park

(formerly known as Clay Business Park)

Town of Clay, New York 13041

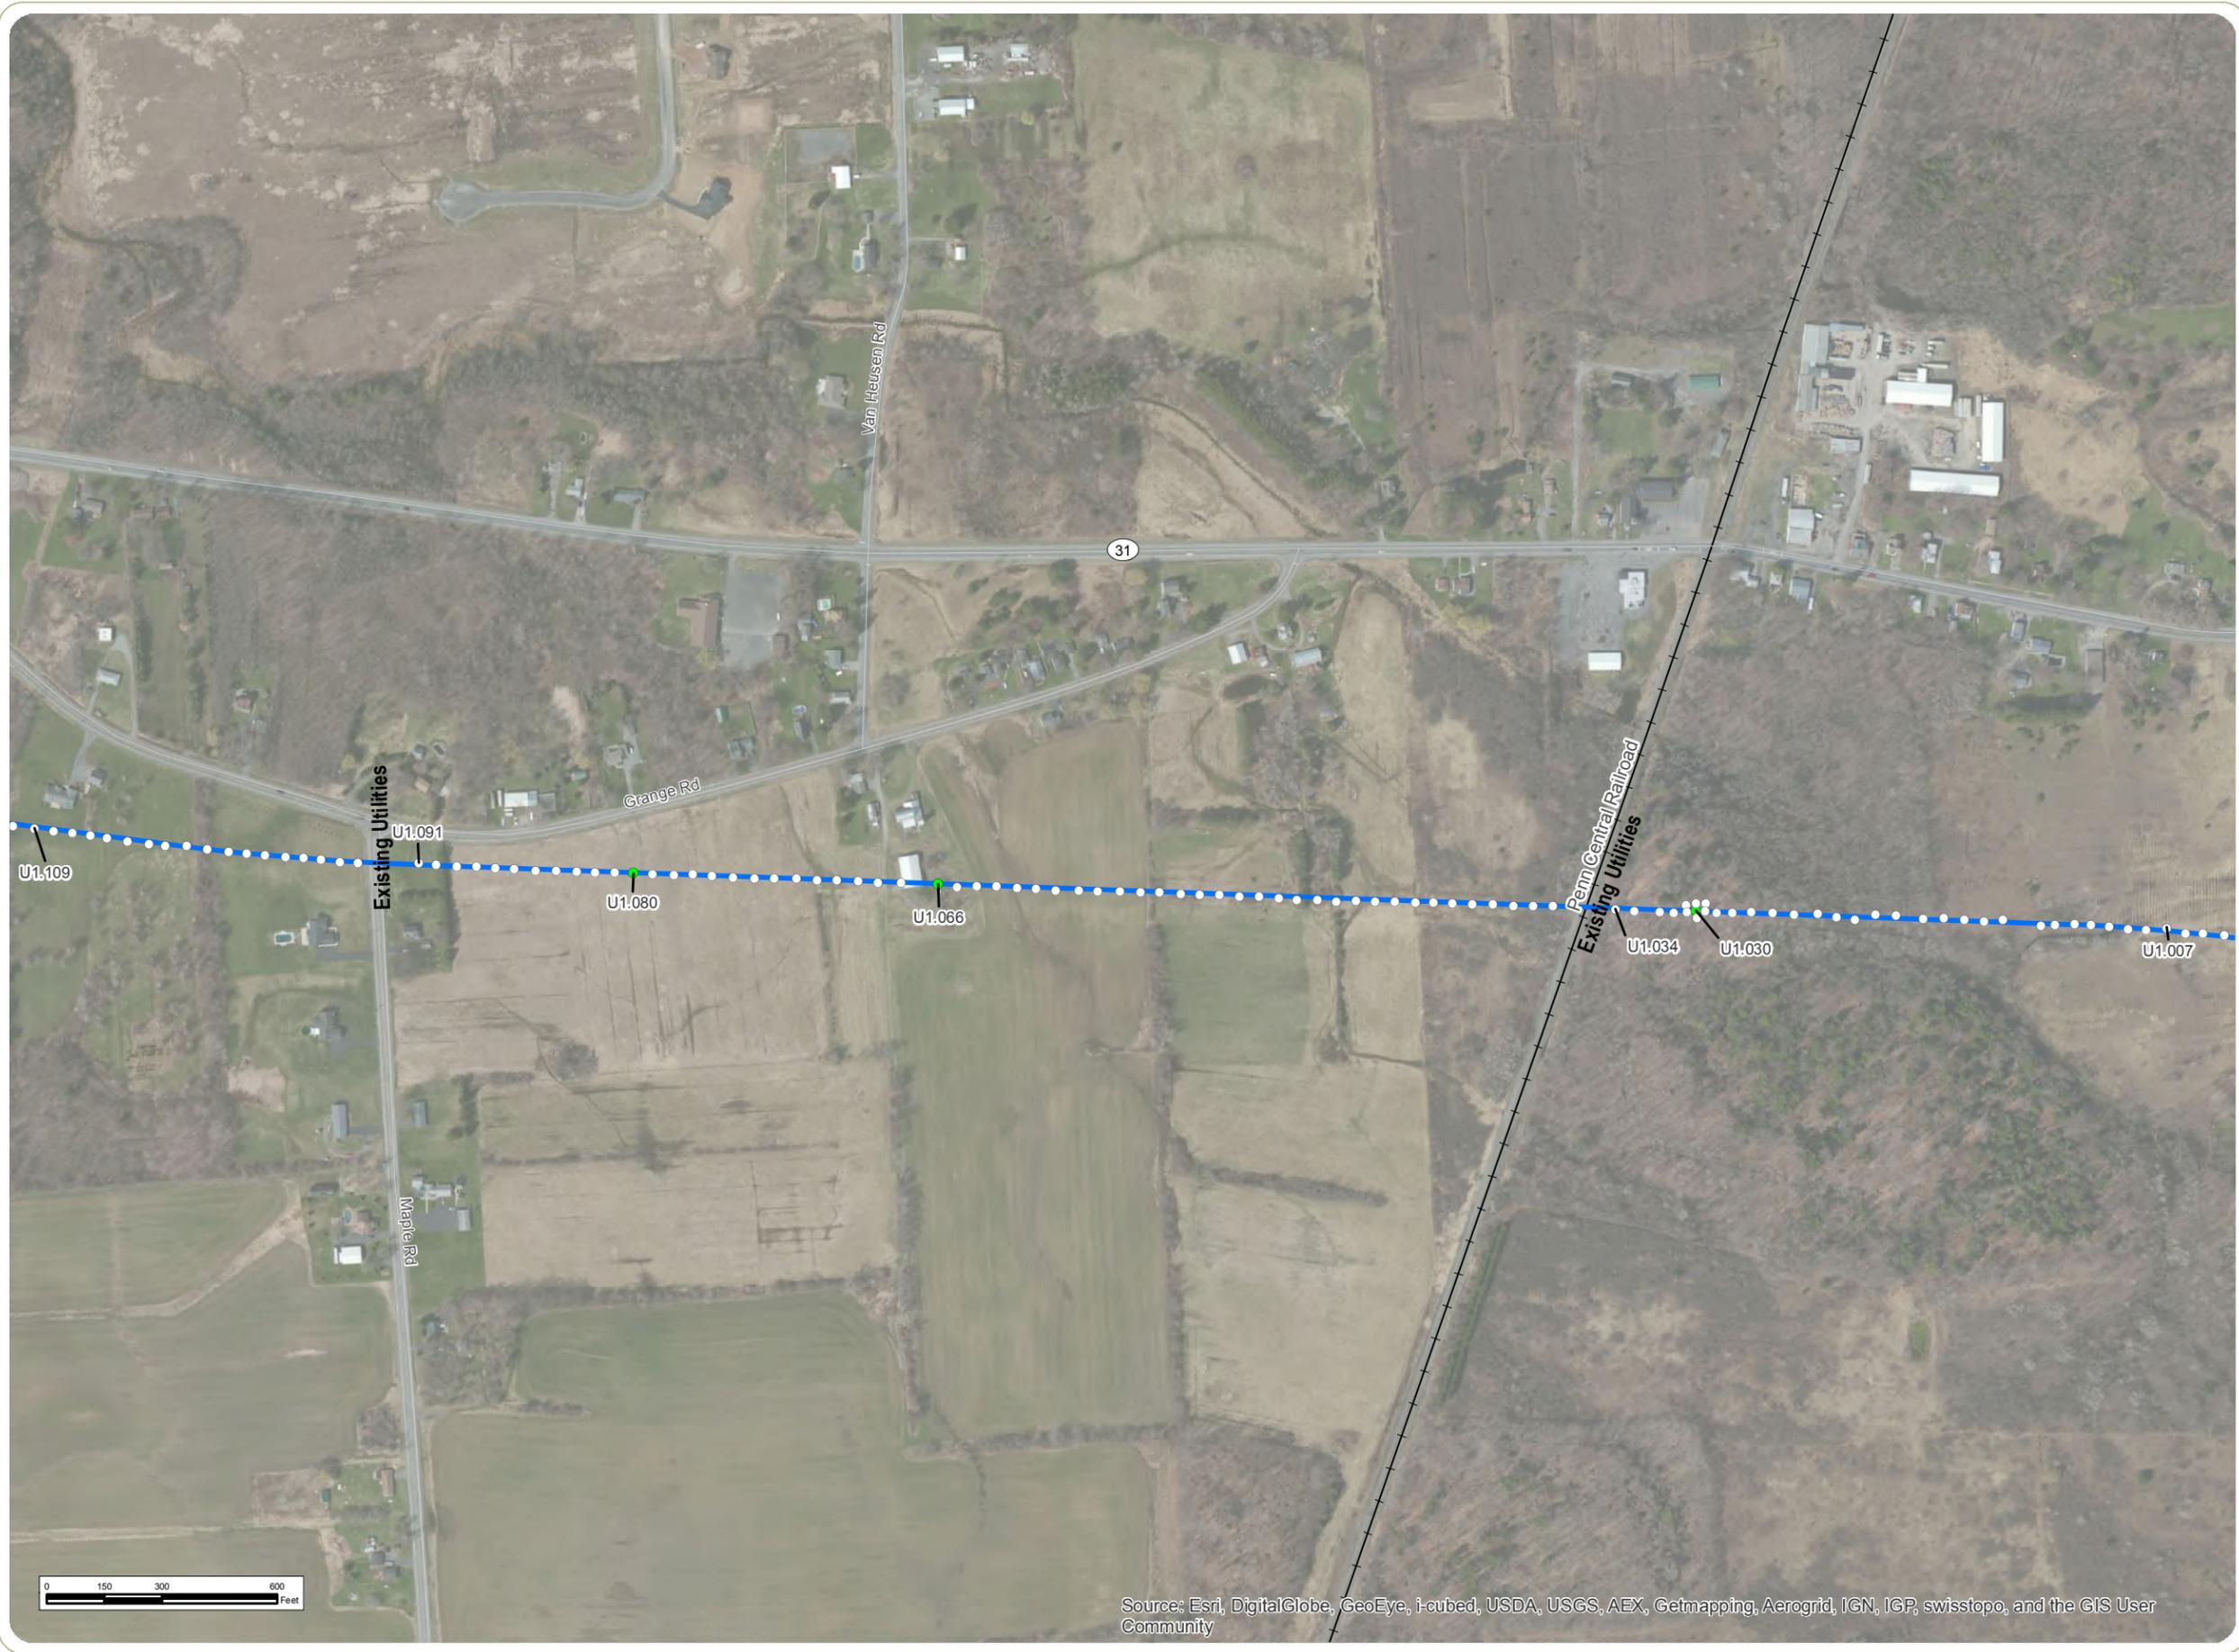
**Figure 13: Phase 1
Archeological Survey Map**
Sheet 4 of 6

- Shovel Test Location
- Historic Material
 - No Cultural Material
 - MDS Site Shovel Test
 - Proposed Sewerline
 - Archeological Survey Area
 - Buildable Area
 - Project Site

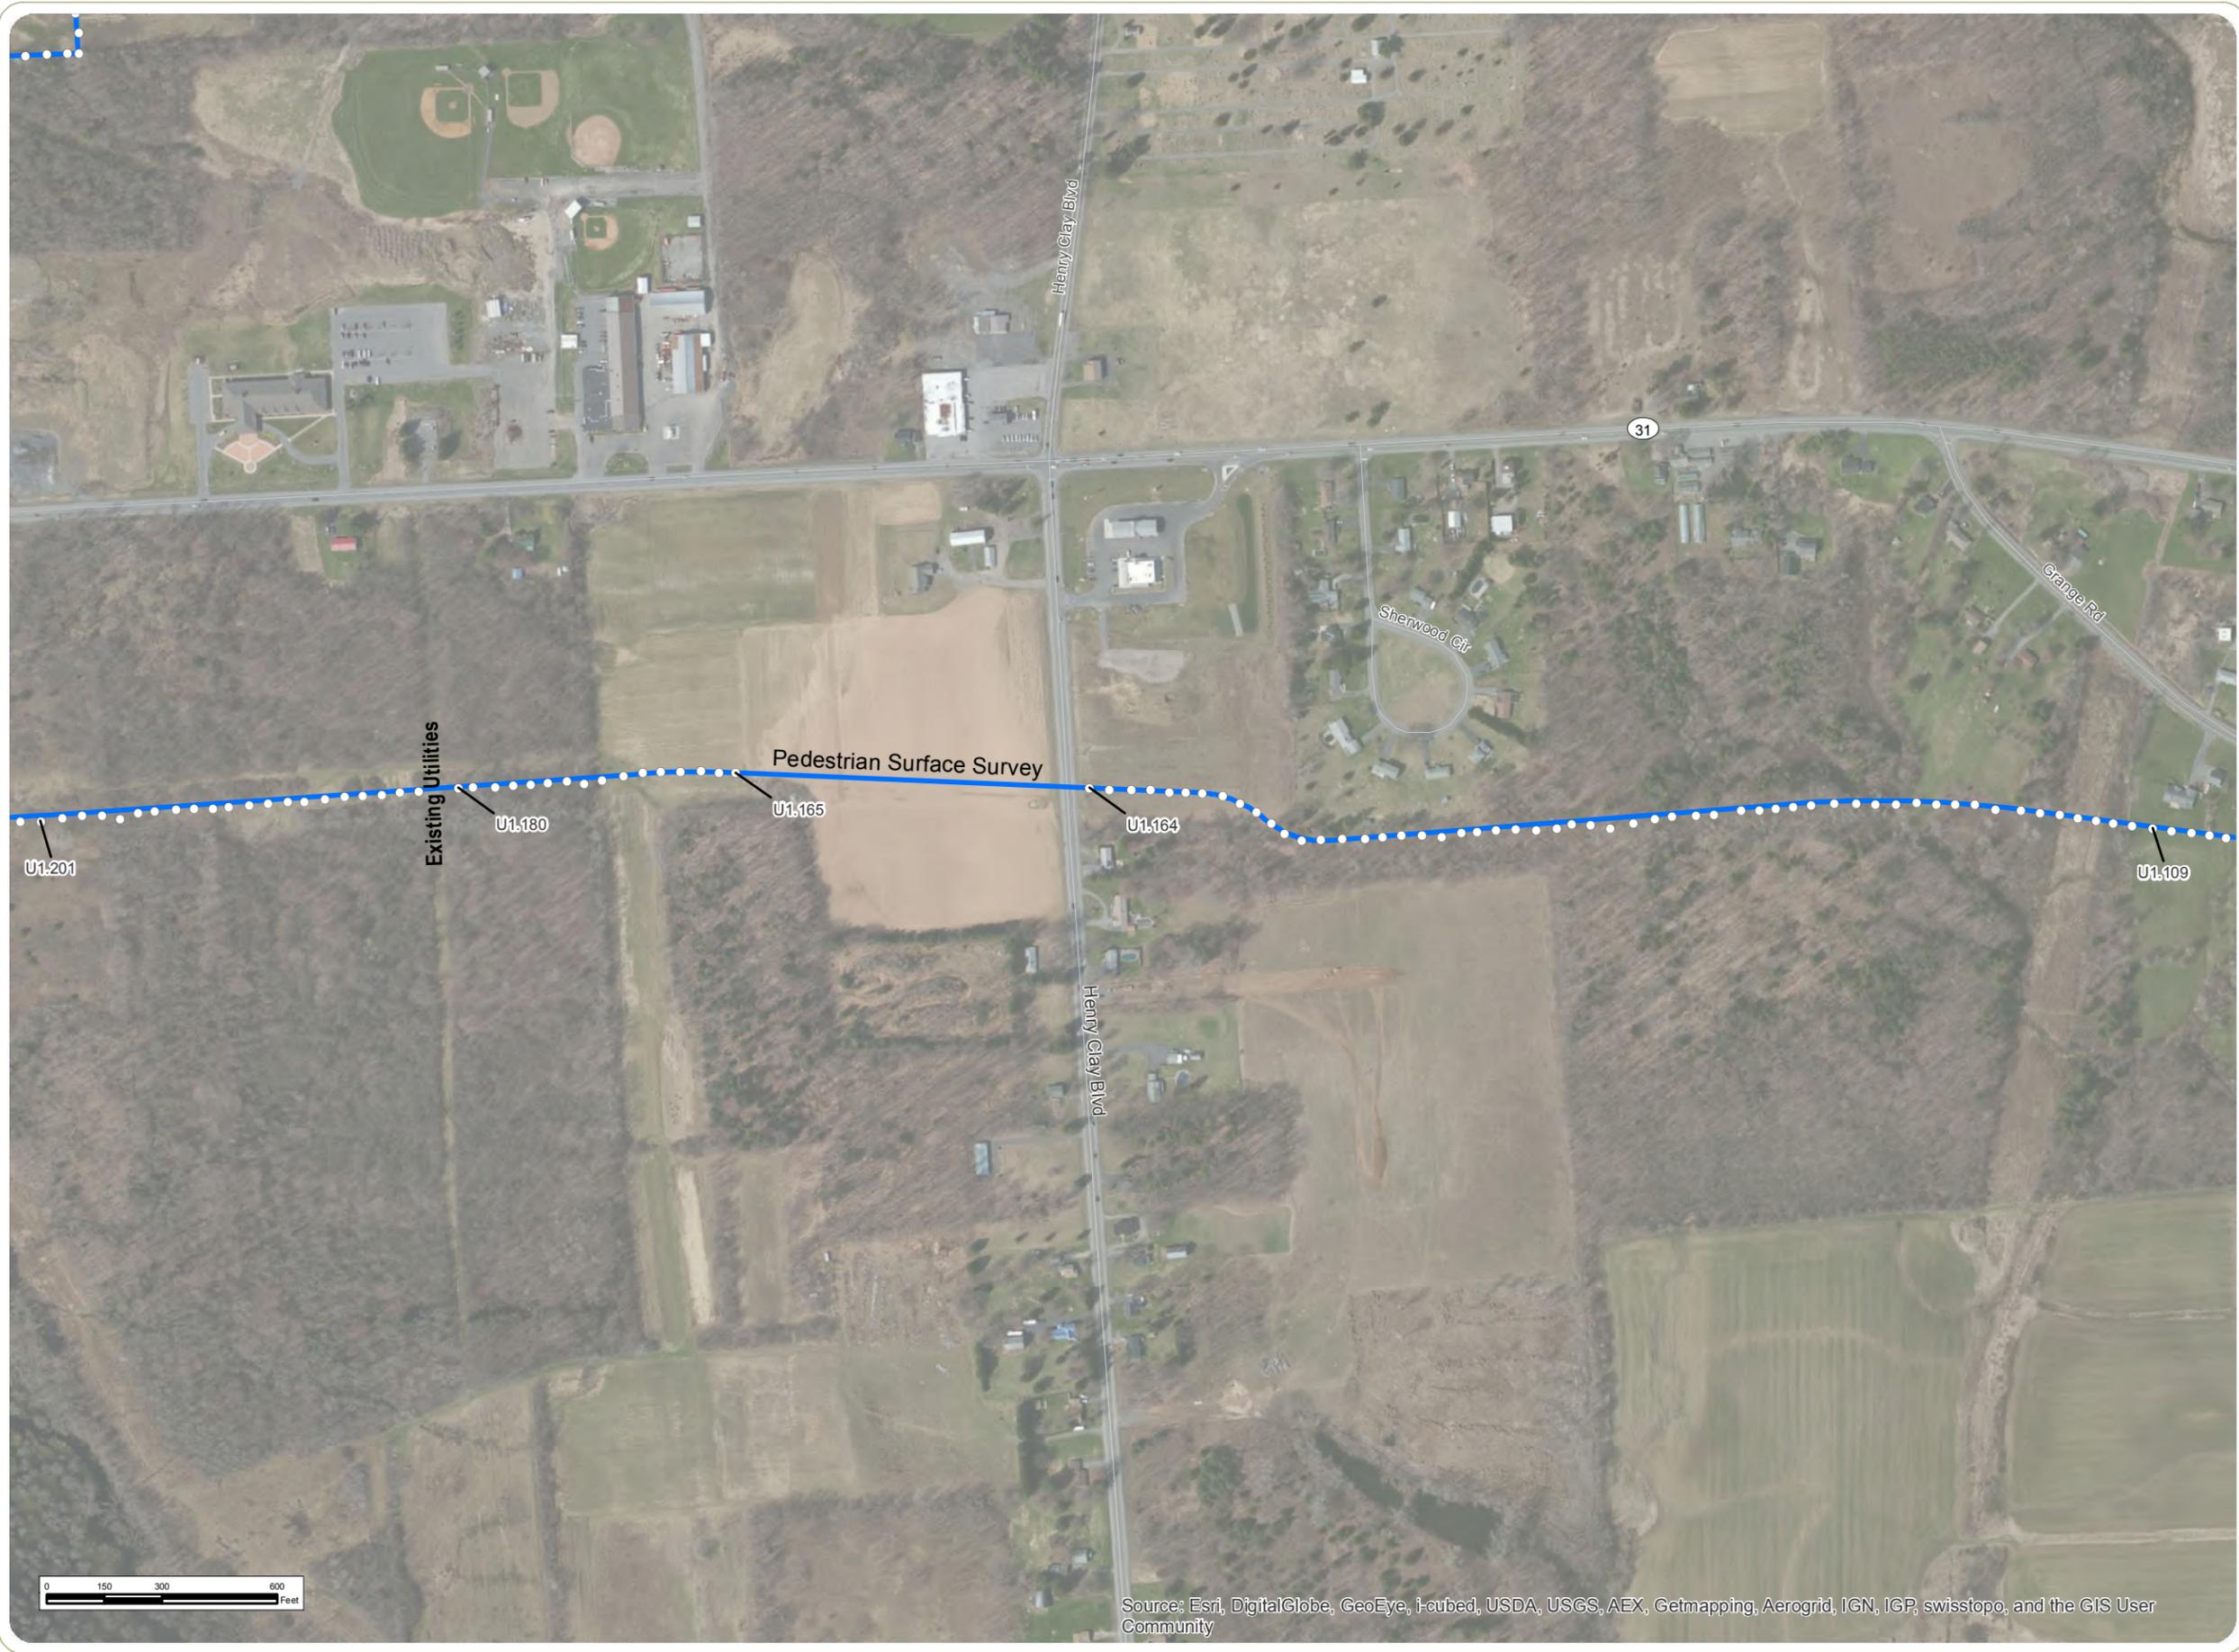
**Figure 13: Phase 1
Archeological Survey Map**
Sheet 5 of 6

- Shovel Test Location
- Historic Material
 - No Cultural Material
 - MDS Site Shovel Test
 - Proposed Sewerline
 - Archeological Survey Area
 - Buildable Area
 - Project Site

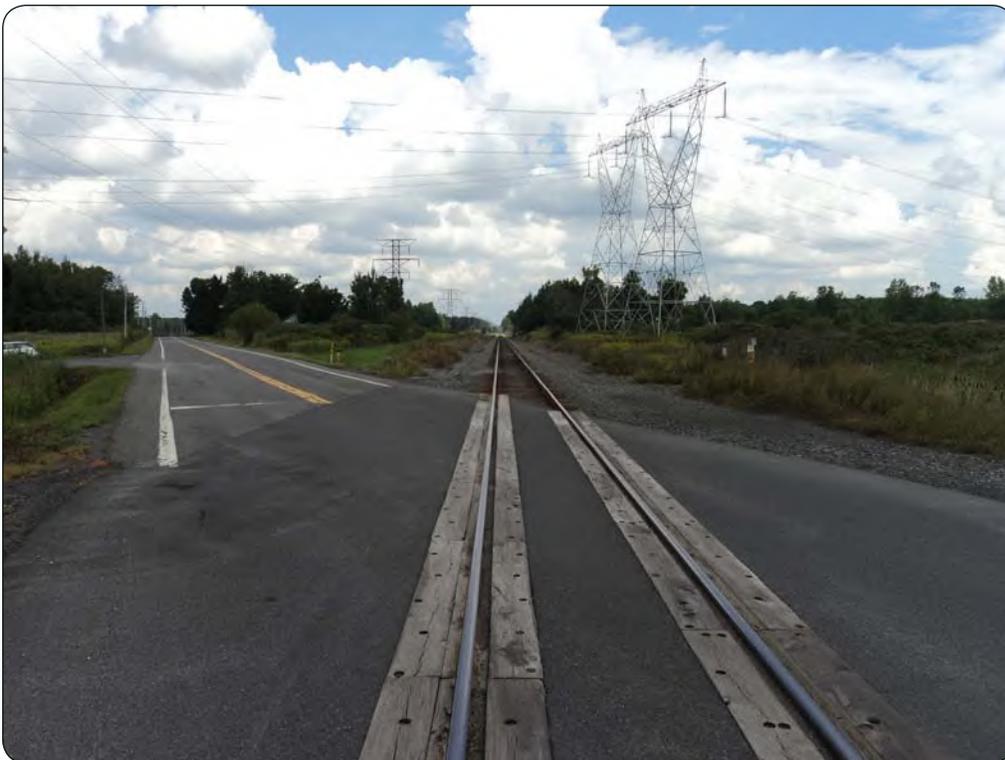
Photo 06

CSX Railroad tracks along the northwestern perimeter of the Project site, view to the northeast.

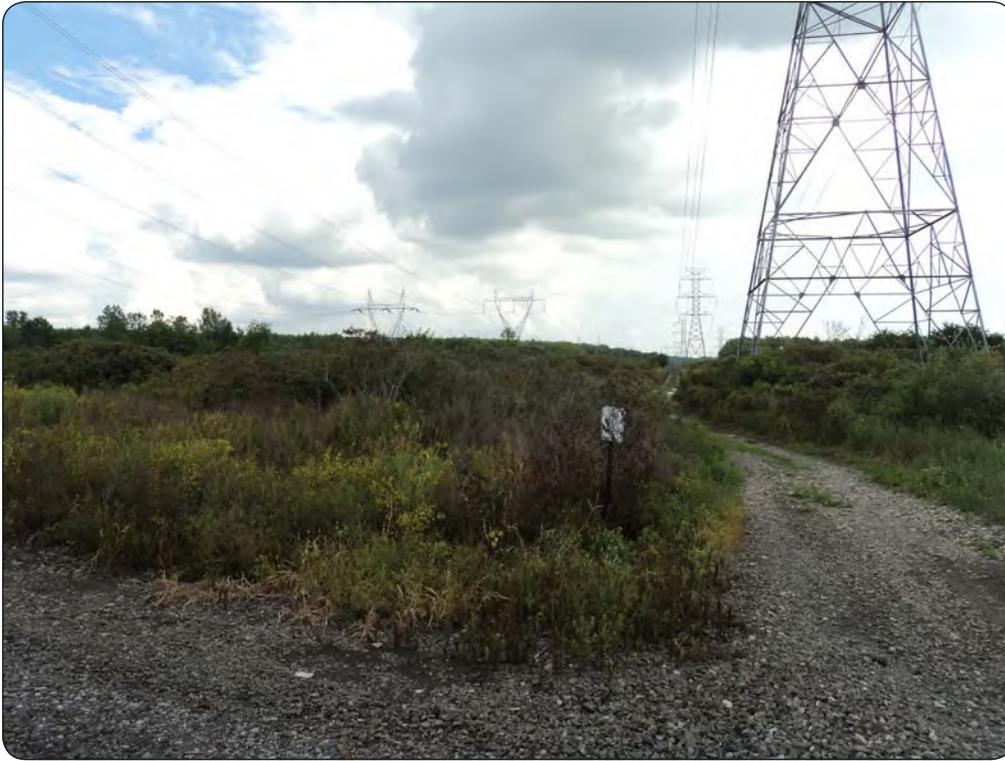
Photo 07

NYPA transmission line and right-of-way within the northern portion of the Project site, view to the east.

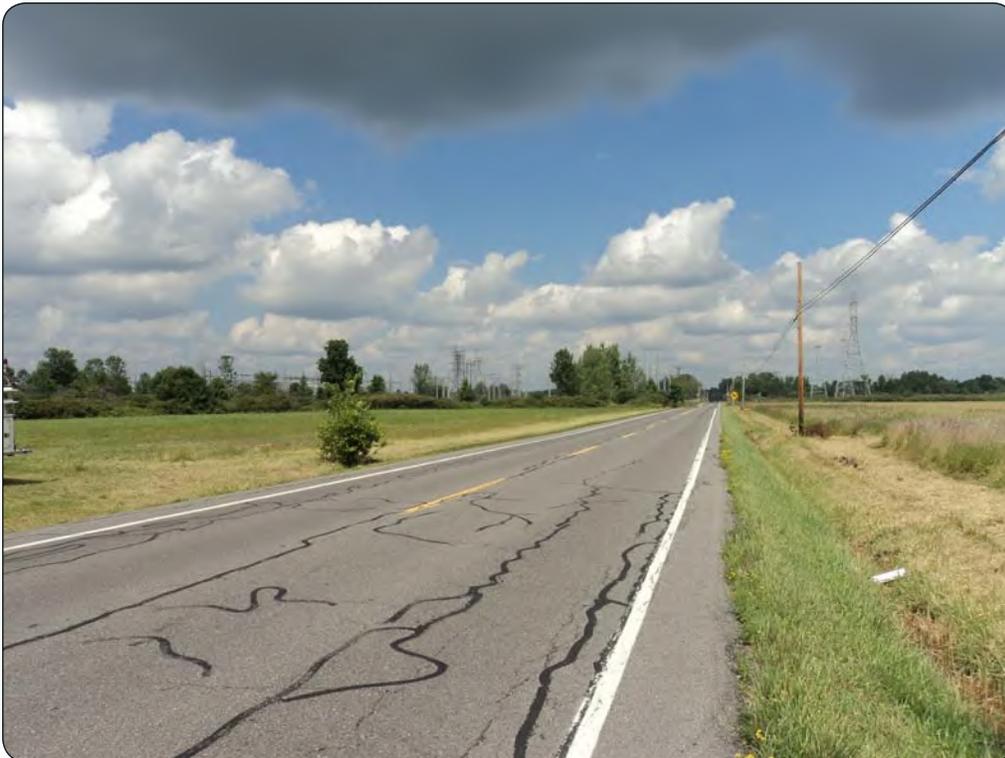
Photo 08

NYPA transmission line and CSX Railroad crossing Caughdenoy Road, view to the north.

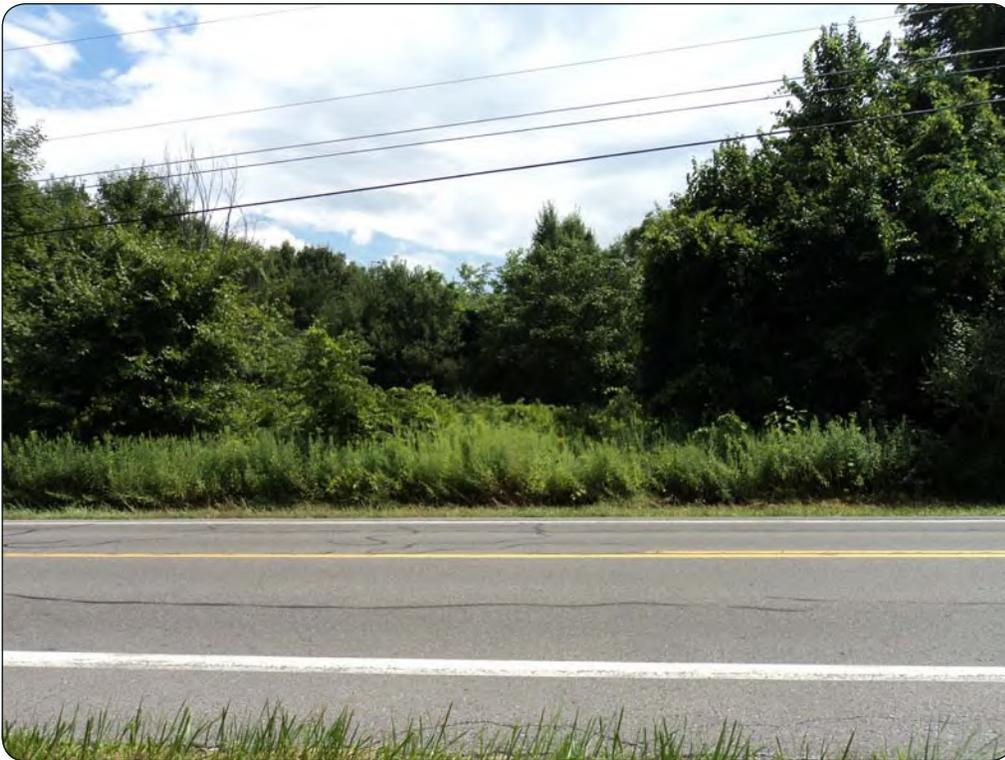
Photo 09

Location of MDS Site 1 within the Project site; view to the east.

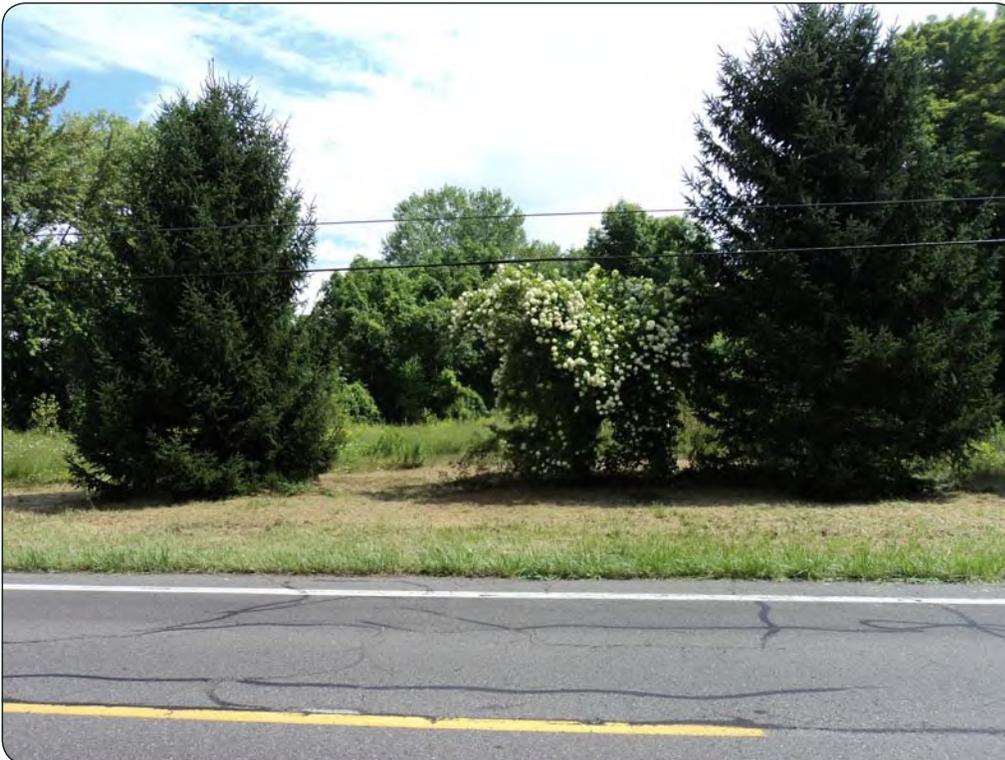
Photo 10

Location of MDS Site 2 within the Project site; view to the east.

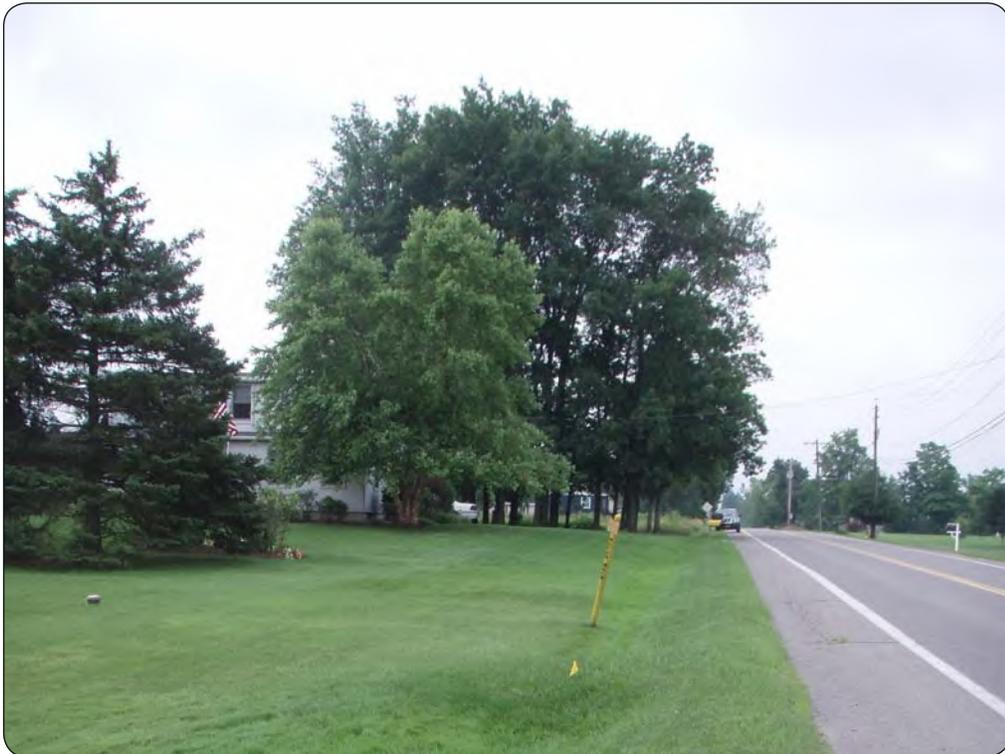
Photo 68

View along sewer line route, depicting marked-out gas line along eastern edge of Maple Road. View to the south.

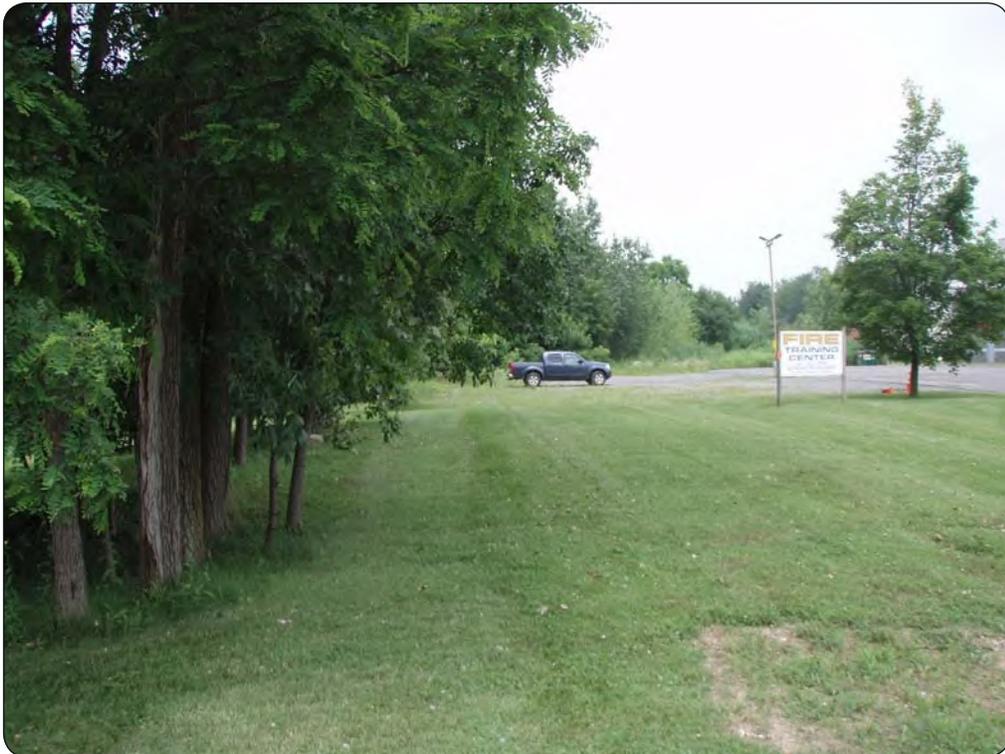
Photo 73

View along sewer line route, depicting buried gas line running east-west across sewer line route. View to the west.

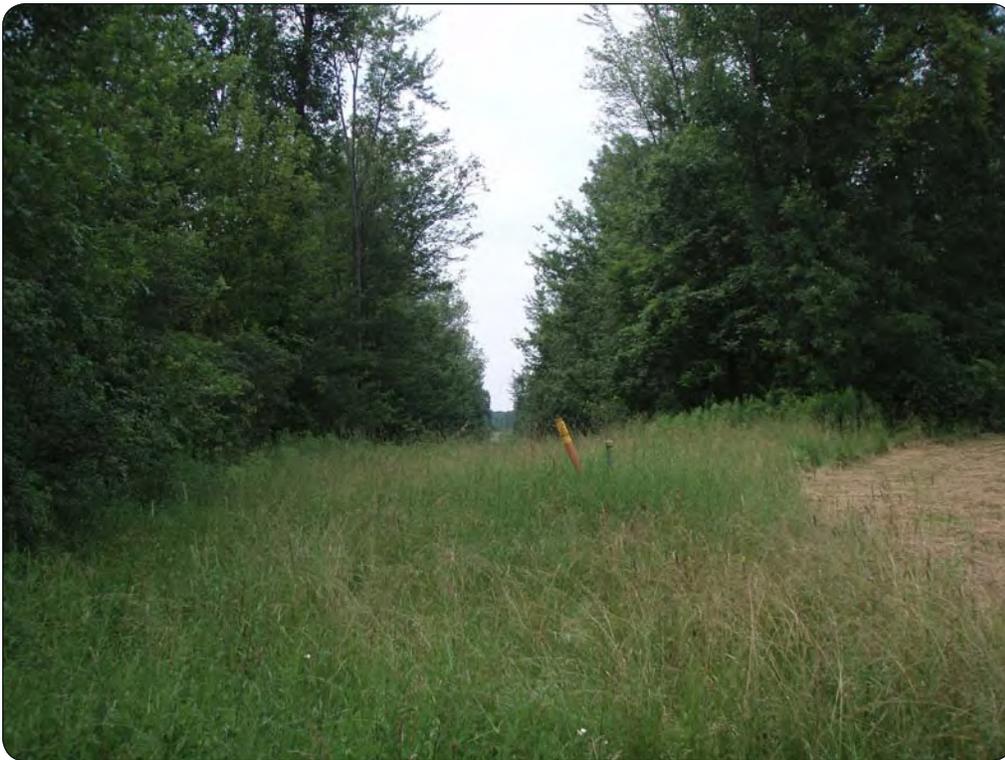
Photo 72

View along sewer line route, depicting built conditions near to NY State Route 31. View to the north.

No shovel tests were excavated in areas previously disturbed by existing utilities. The results of the utility mark outs (and results of shovel testing in some areas) indicate that many segments of the proposed sewer line are located in previously disturbed areas (see Figure 13: Sheets 3-6, and Appendix A: Photographs 69, 70, 72).

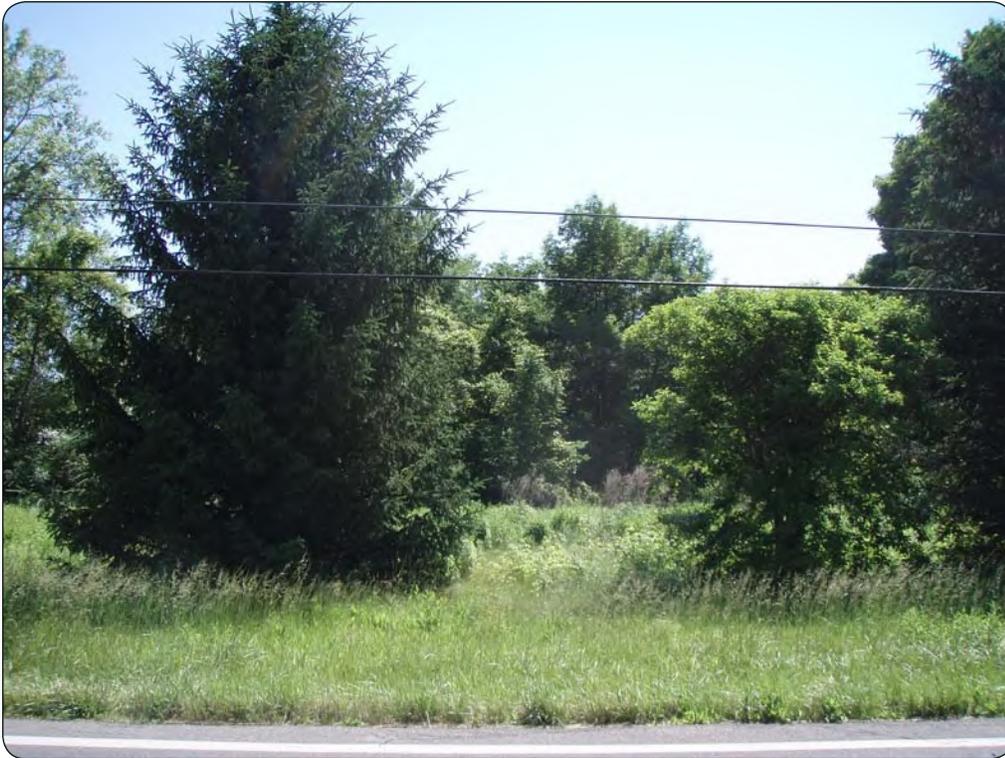
Photo 74

View along sewer line route, depicting marked-out buried telecommunications line along southern edge of Verplanck Road. View to the east.

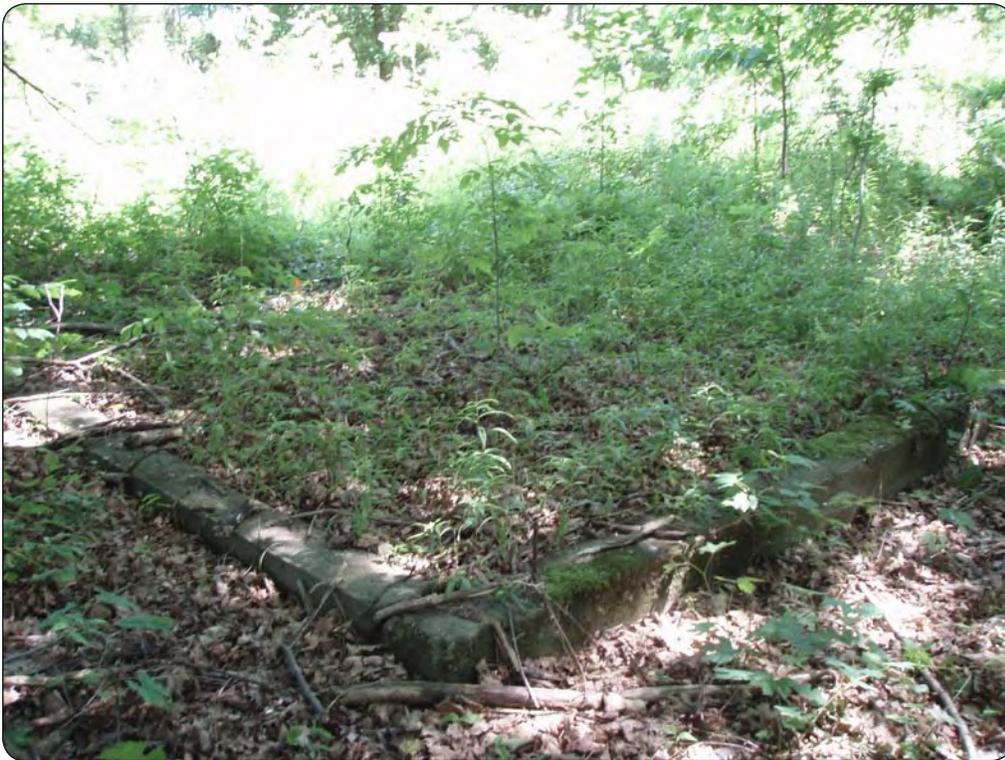
Photo 77

View of former garage/carport foundation (Feature B1) located within Caughdenoy Road MDS 1. View to the southeast.

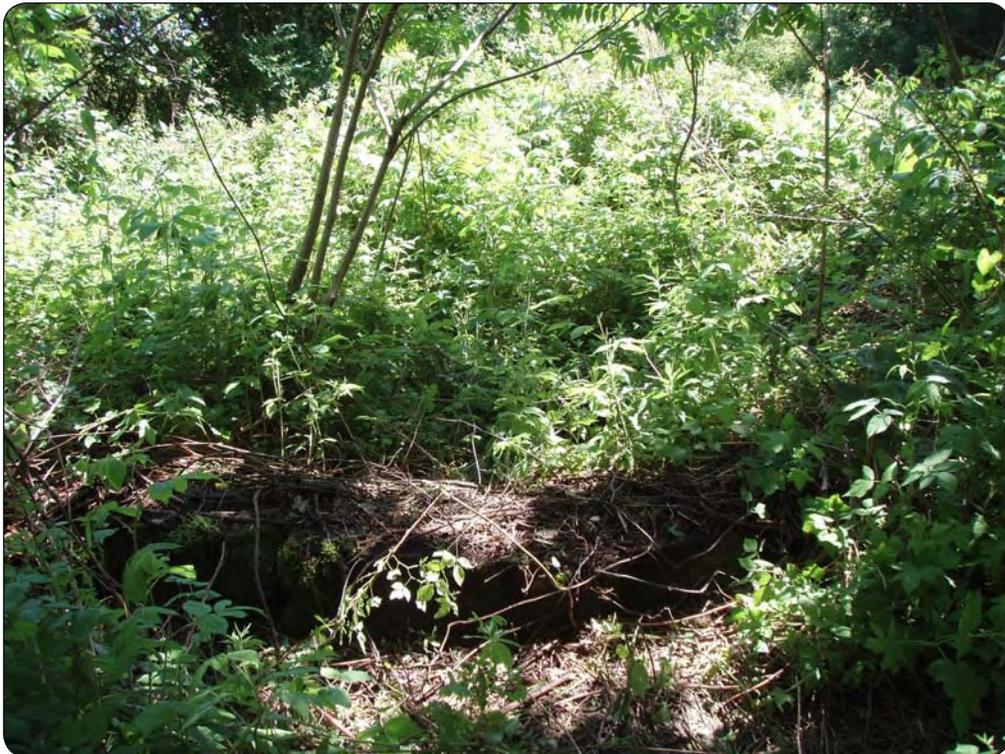
Photo 78

View of concrete foundation of a silo (Feature B2) within Caughdenoy Road MDS 1. View to the east.

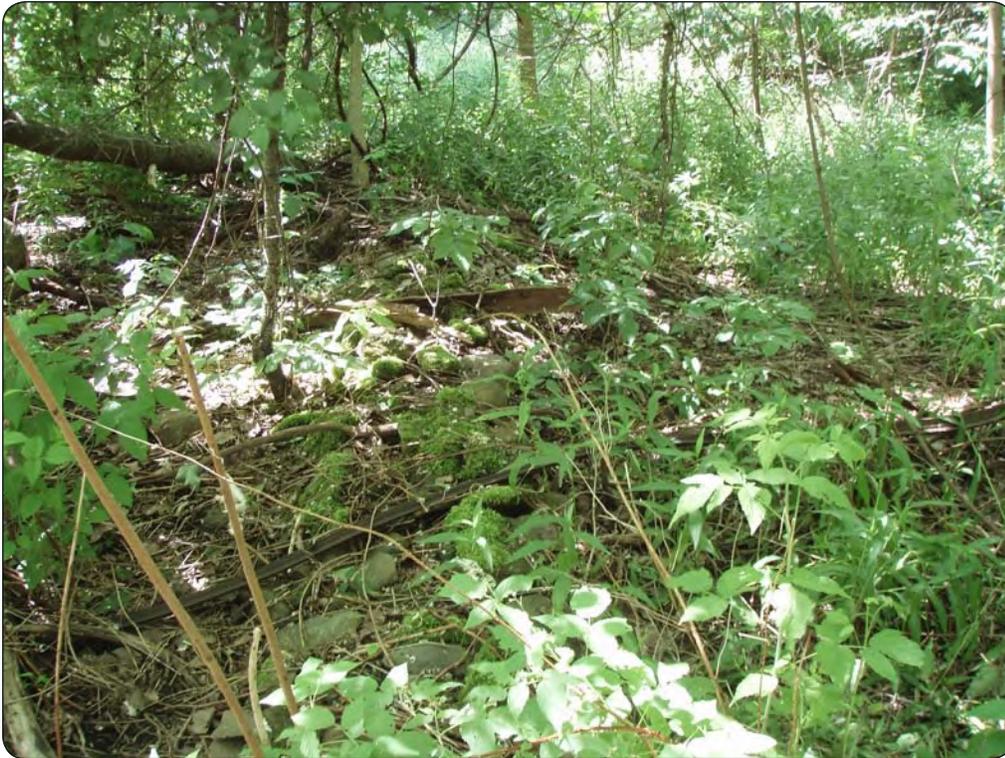
Photo 79

View of fieldstone/concrete foundation segment (Feature B3) of probable barn located within Caughdenoy Road MDS 1. View to the east.

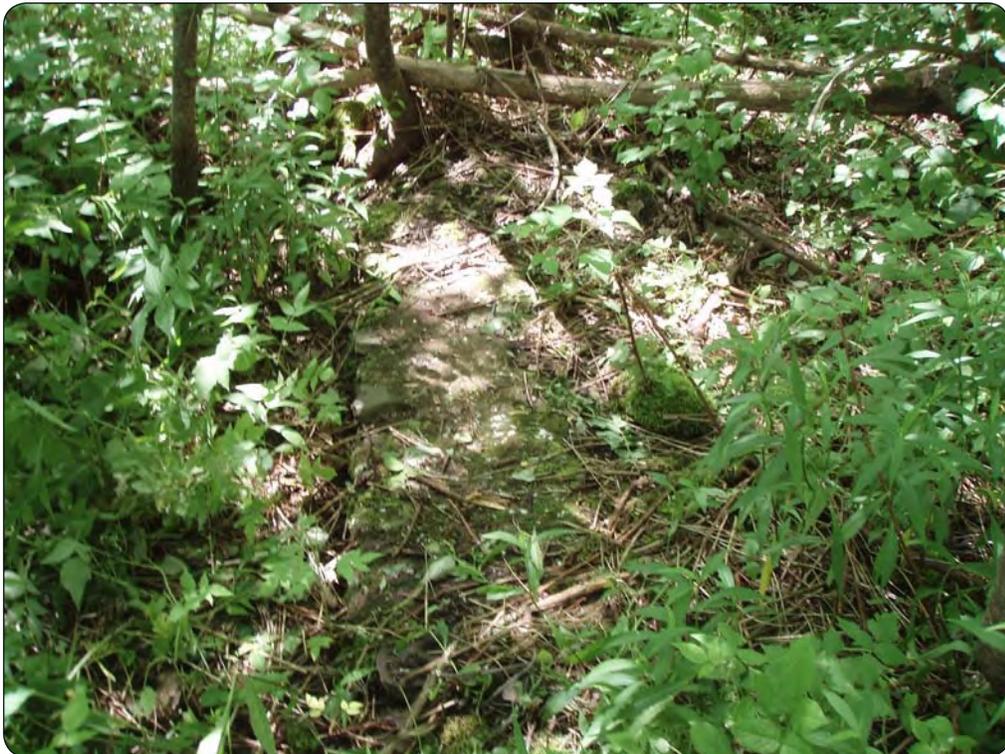
Photo 80

Detail of fieldstone/concrete barn foundation (Feature B3) within Caughdenoy Road MDS 1. View to the south.

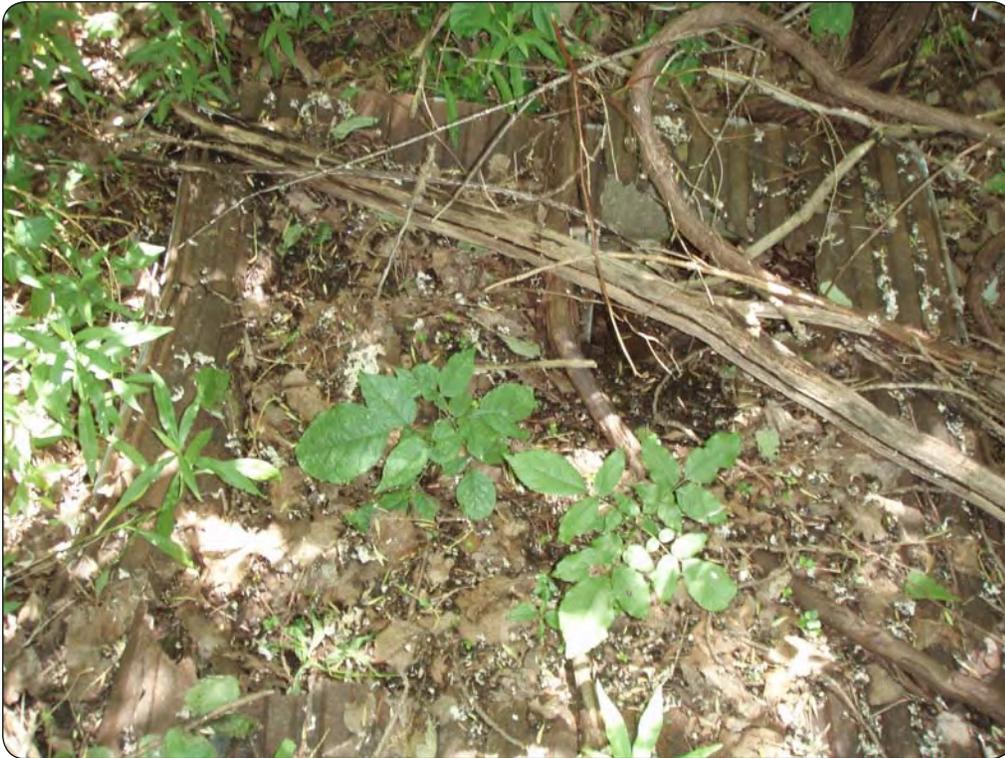
Photo 81

Detail view of concrete block-lined well or cistern (Feature B4), with corrugated sheet metal cover, located within Caughdenoy Road MDS 1.

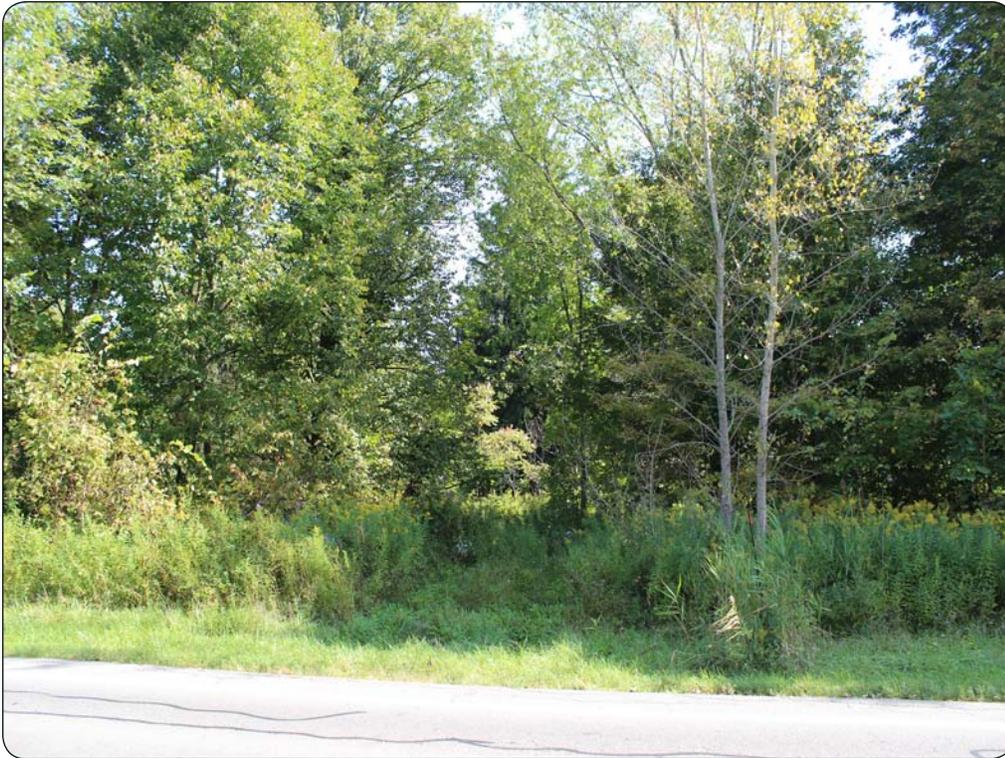
Photo 82

Detail of push-pile and refuse mound located east of former house site at Caughdenoy Road MDS 1. View to the northeast.

In addition, as described above there is a series of push-piles located east of the former house site, located between approximately B.N200 and B.N300 and between B.E175 and B.E225 (see Figure 14). Scattered piles of domestic refuse are distributed on the ground surface across and around these push piles. This refuse includes metal buckets, paint cans, metal drums/barrels, box-springs, metal hardware (bolts, rods, and cables), agricultural implements, automobile/truck parts, rubber tires, concrete blocks/fragments, butchered bone fragments, canning and mason jars, stoneware crocks, plastic jugs/bottles, and glass bottles ((Photograph 82)). None of these materials were collected for further analysis. In general, the dates of the materials included in this scattered rubbish are consistent with the assumed abandonment of the property, i.e., during the mid to late twentieth century.

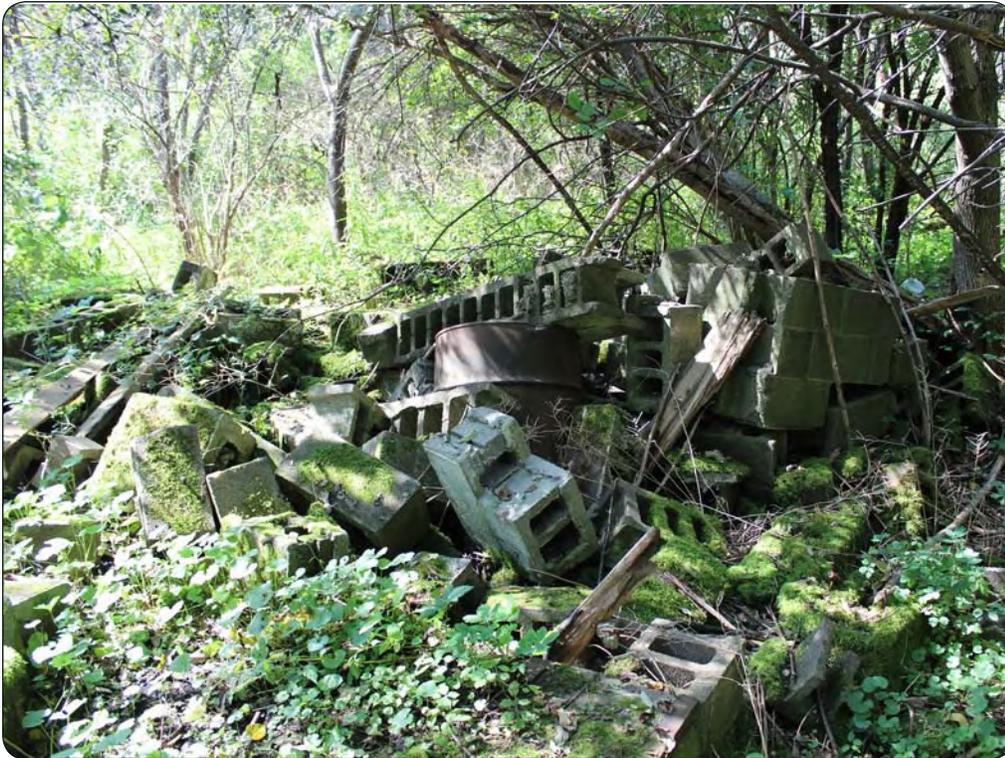
Photo 85

View of barn foundation (Feature C1) and depression at Caughdenoy Road MDS 2. View to the southwest.

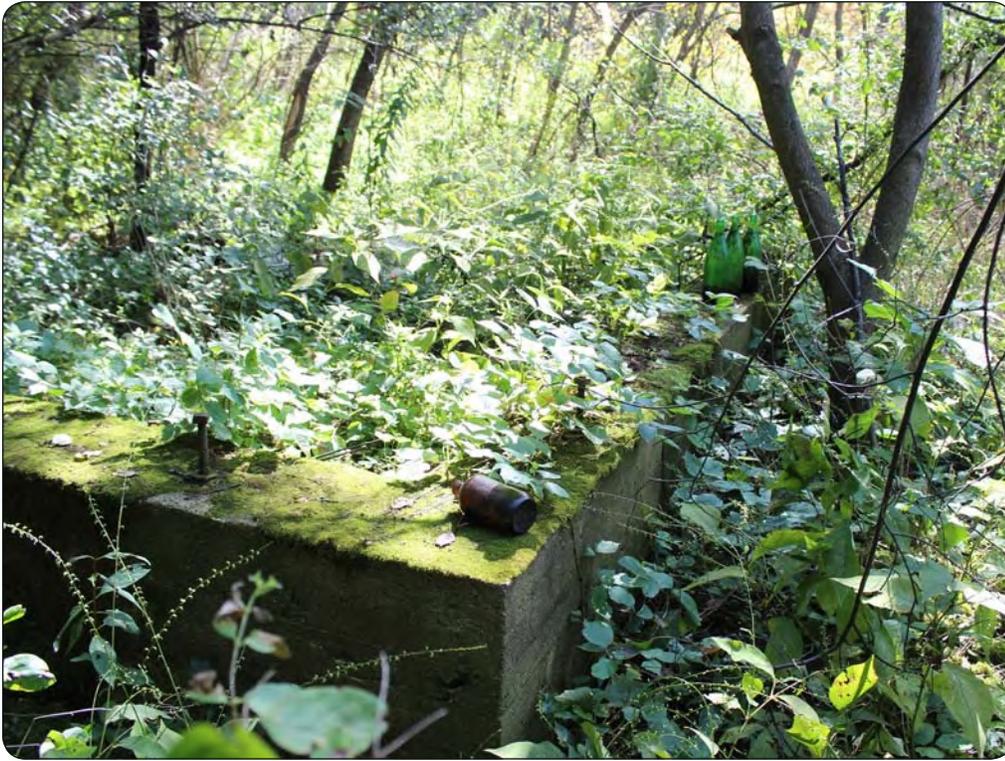
Photo 86

View of barn foundation (Feature C1) and depression at Caughdenoy Road MDS 2. View to the northeast.

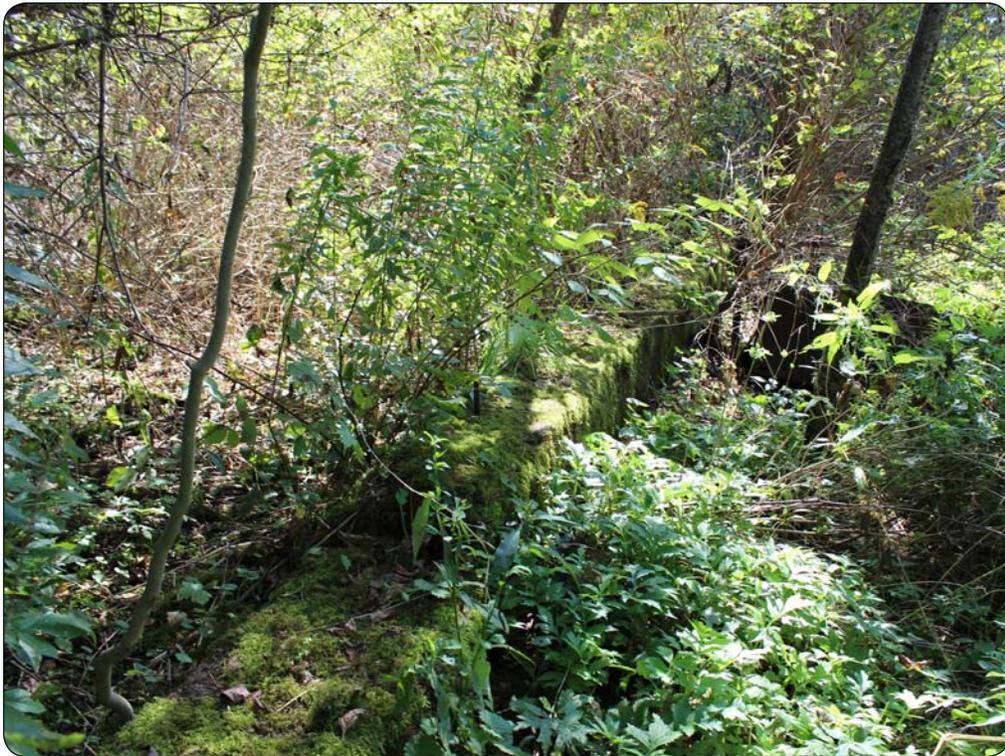
Photo 87

View of barn foundation (Feature C1) at Caughdenoy Road MDS 2. View to the southeast.

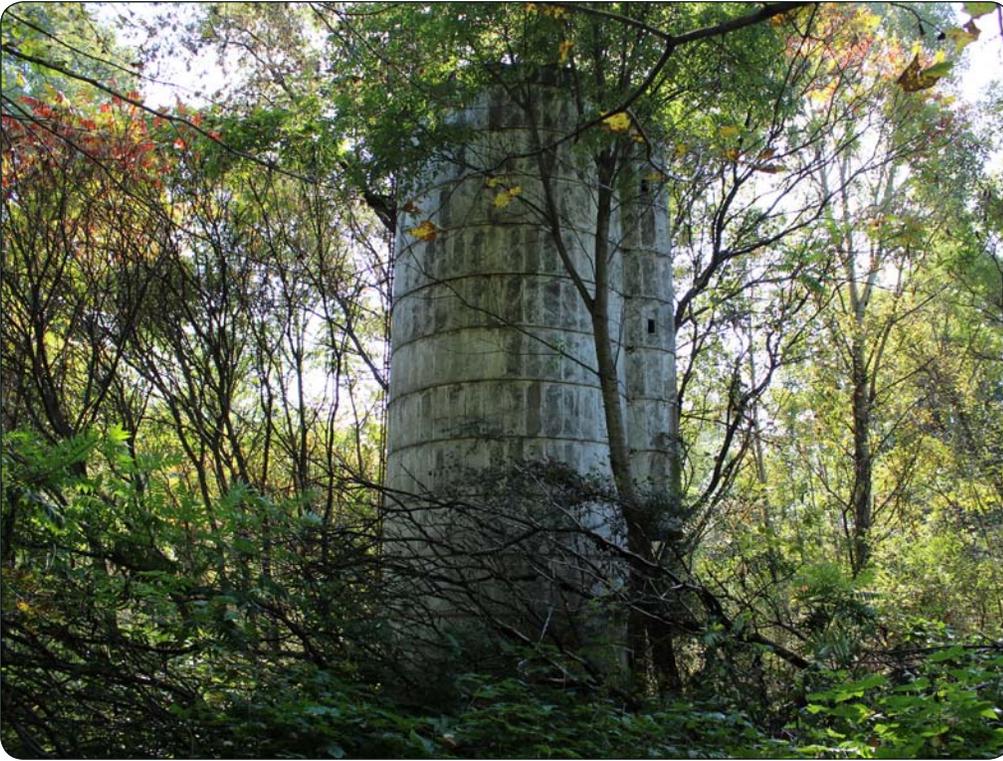
Photo 89

View of concrete silo (Feature C2) at Caughdenoy Road MDS 2. View to the south.
