**FINAL GENERIC
ENVIRONMENTAL IMPACT STATEMENT**

White Pine Commerce Park

(formerly known as Clay Business Park)

Town of Clay, New York 13041

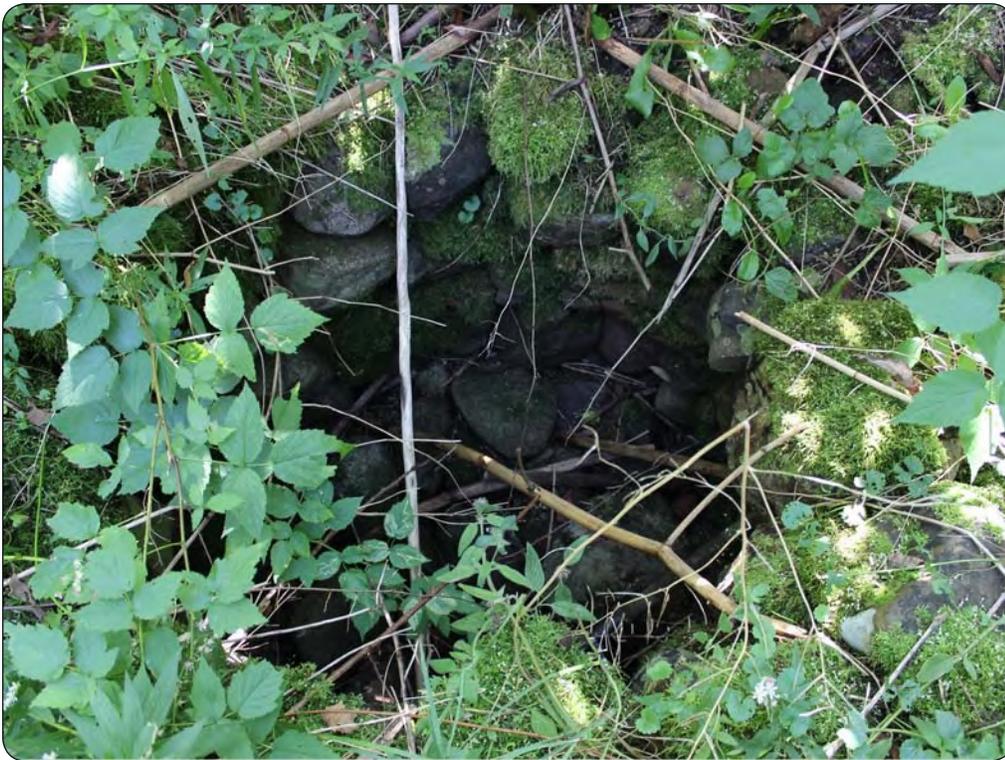
Photo 90

View of modern well (Feature C3) east of barn foundation at Caughdenoy Road MDS 2. View to the north.

- **Feature C3** is a modern well, consisting of a capped steel pipe, approximately three inches in diameter and standing 24 inches above surrounding grade (Photograph 90). The well is located at approximately C.N490-E.260. The well is located approximately 50 feet east of the large concrete silo (Feature C2).

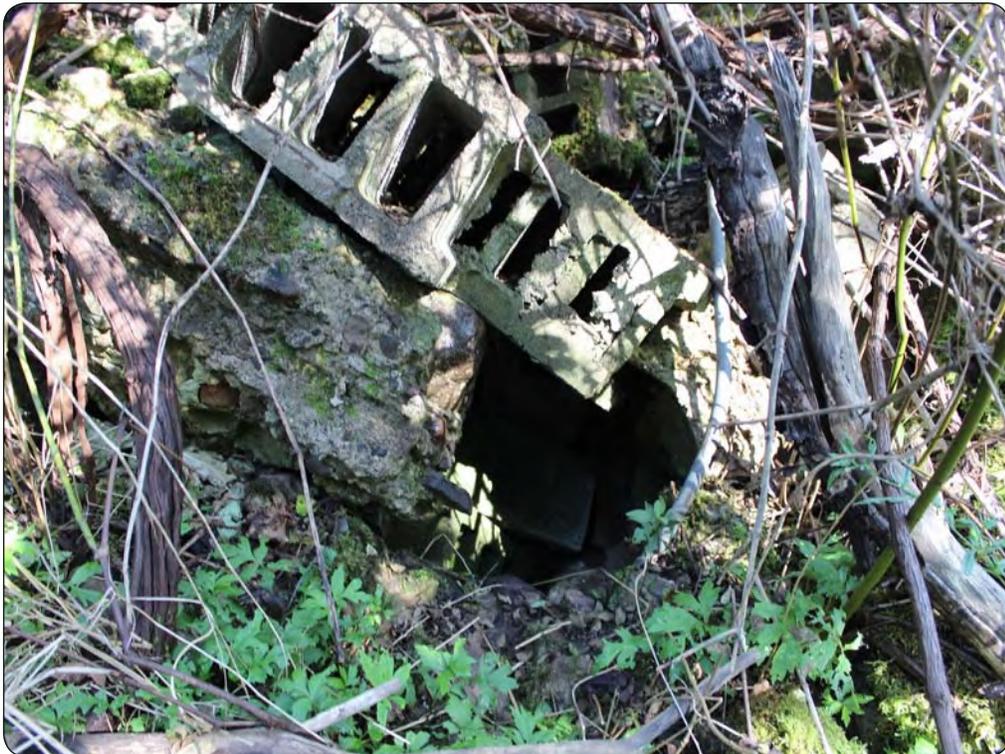
Photo 92

View of dry-laid, debris-filled fieldstone well (Feature C5) south of barn foundation at Caughdenoy Road MDS 2. View to the north.

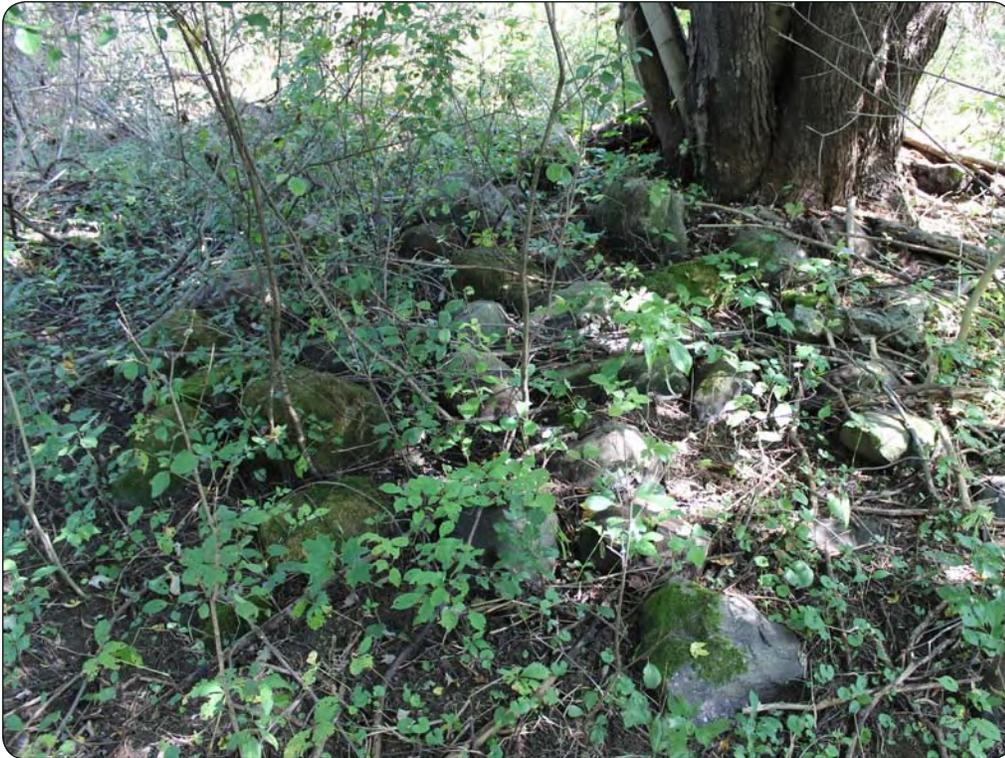
Photo 96

View of modern well (Feature C7) west of barn foundation at Caughdenoy Road MDS 2. View to the southwest.

- **Feature C7** is a modern well, similar to Feature C3, located at approximately C.N450-E100 (Photograph 96).
- **Feature C8** is a small fieldstone pile located at approximately C.N460-E340 (Photograph 97). Four oxidized fragments of nails or metal wire were recovered from shovel test C.450-E350 (adjacent to the feature; see below). Otherwise, no indications of a structure or other feature were observed and it is likely that this pile represents stones resulting from field clearing activities.

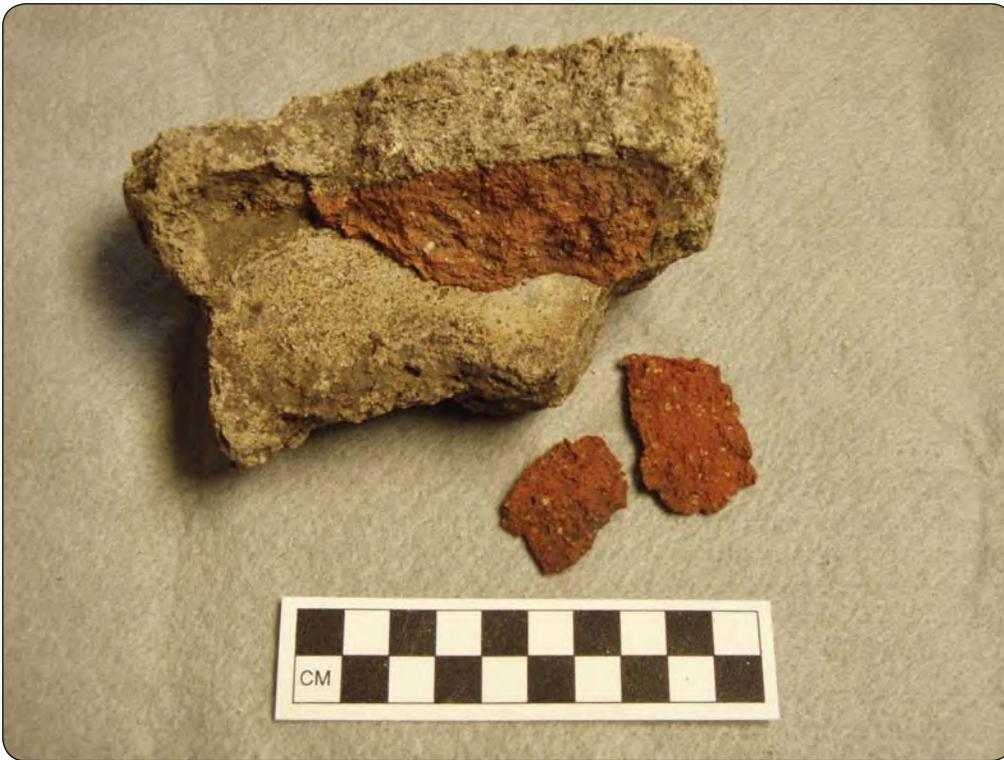
Photo 110

Representative selection of other architectural materials recovered from the archeological survey of Caughdenoy Road MDS 2. Pictured: stone slab with mortar, previously attached to larger architectural stone.
